OWS Tiles - 600x300mm Maria Lara Tiles - Wet Sliptest SN270223-4

Slip Resistance Classification of New Pedestrian Surfaces - AS4586:2013 Appendix A

Date Tested:	27 Feb 2023
Test Report Number:	SN270223-4
Client Name & Billing Address:	OWS International Building Materials Pty Ltd - Unit 1/17 Pavesi Street, Smithfield NSW 2164
Project Name or Test Location:	Sliptest Australia NSW Headquarters - 4 Bindon Place, Zetland NSW 2017
Surface Tested : (Samples and Test Information Supplied by Client)	600x300cm Maria Lara - Light Grey Stone Look Tile / Anti Slip
Wet Pendulum Test carried out using :	Slider 96 (4S) Rubber slider
Any Variations to Standards	N/A
Testing Officer / Approved Signatory:	Shenea Neill
Pendulum in use - Calibration Date :	#1133 - Munro-Stanley Portable Skid Tester (C : 14.10.21)

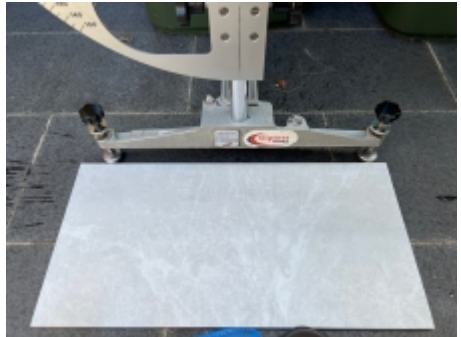
Sample No.	Swing 1	Swing 2	Swing 3	Swing 4	Swing 5	Mean BPN of last 3 swings :	SCV :	Surface Picture
Tile 1	56	56	55	55	55	55	N/A	
Tile 2	55	54	54	53	53	53	N/A	
Tile 3	55	55	55	55	55	55	N/A	
Tile 4	56	56	55	55	54	55	N/A	
Tile 5	56	56	55	55	55	55	N/A

Reported SRV For Test Area : 55

CLASSIFICATION using Slider 96 (4S Slider) P5 = > 54
